# Keep it Moving

RAY-CARROLL ELEVATOR ADDS 75% RECEIVING CAPACITY WITHOUT PAUSING OPERATIONS

**Ray-Carroll County Grain Growers, Inc.'s** 2.8-million-bushel country elevator in Carrollton, MO needed increased receiving capacity in order to better accommodate its growing customer base.

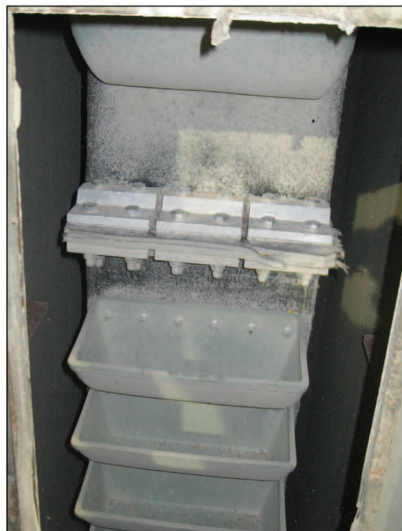
*4B BC1 belt splice clamps and JUMBO™ CC-S® 16x8 low-profile buckets spaced 7.75 inches apart on 1,000-piw rubber belting. Photo courtesy of 4B Components.*

**4B JUMBO™ CC-S® 16x8 low-profile buckets** were installed and spaced 7.75 inches apart. “We’re really pleased with the new buckets,” says Heddings. “The low-profile design allowed us to install the buckets closer together, so we were able to fit 624 buckets on each leg.” Before, each leg held 400 buckets spaced 12 inches apart.

**Eighteen-inch 1,000-piw (pounds per inch of belt width) rubber belting** was supplied by **IBT** to handle the increased bucket load. According to Swisher, “not many people opt for 1,000-piw belting, because it’s more expensive, but it’s a great option. It’s very durable and will last for years, which will save you the time and money spent maintaining or replacing standard belting.”

**4B BC1 belt splice clamps**, designed for belts up to 1,000 piw, were installed.

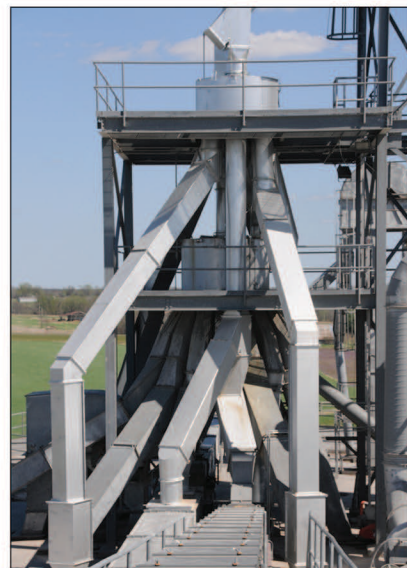
*Modified Rapat distributor with enlarged spouting (middle platform) below a second, new Rapat distributor (top platform). Photo by Tucker Scharfenberg.*

“We also rebuilt our distributor with custom-designed spouting by Rapat, added a new electronic controller, and converted it from dual-flow output to a single, large swing-flow spout to distribute grain to one receiving leg. We then added a second Rapat distributor to accommodate the other receiving leg.
